Subject: Addendum to staff report for Special Use Permit Case No. WSUP18-0008 (Arconic)

## INSPECTION REPORT

FACILITY TITLE: ARCONIC

TYPE OF INSPECTION: COMPLIANCE EVALUATION INSPECTION (CEI)

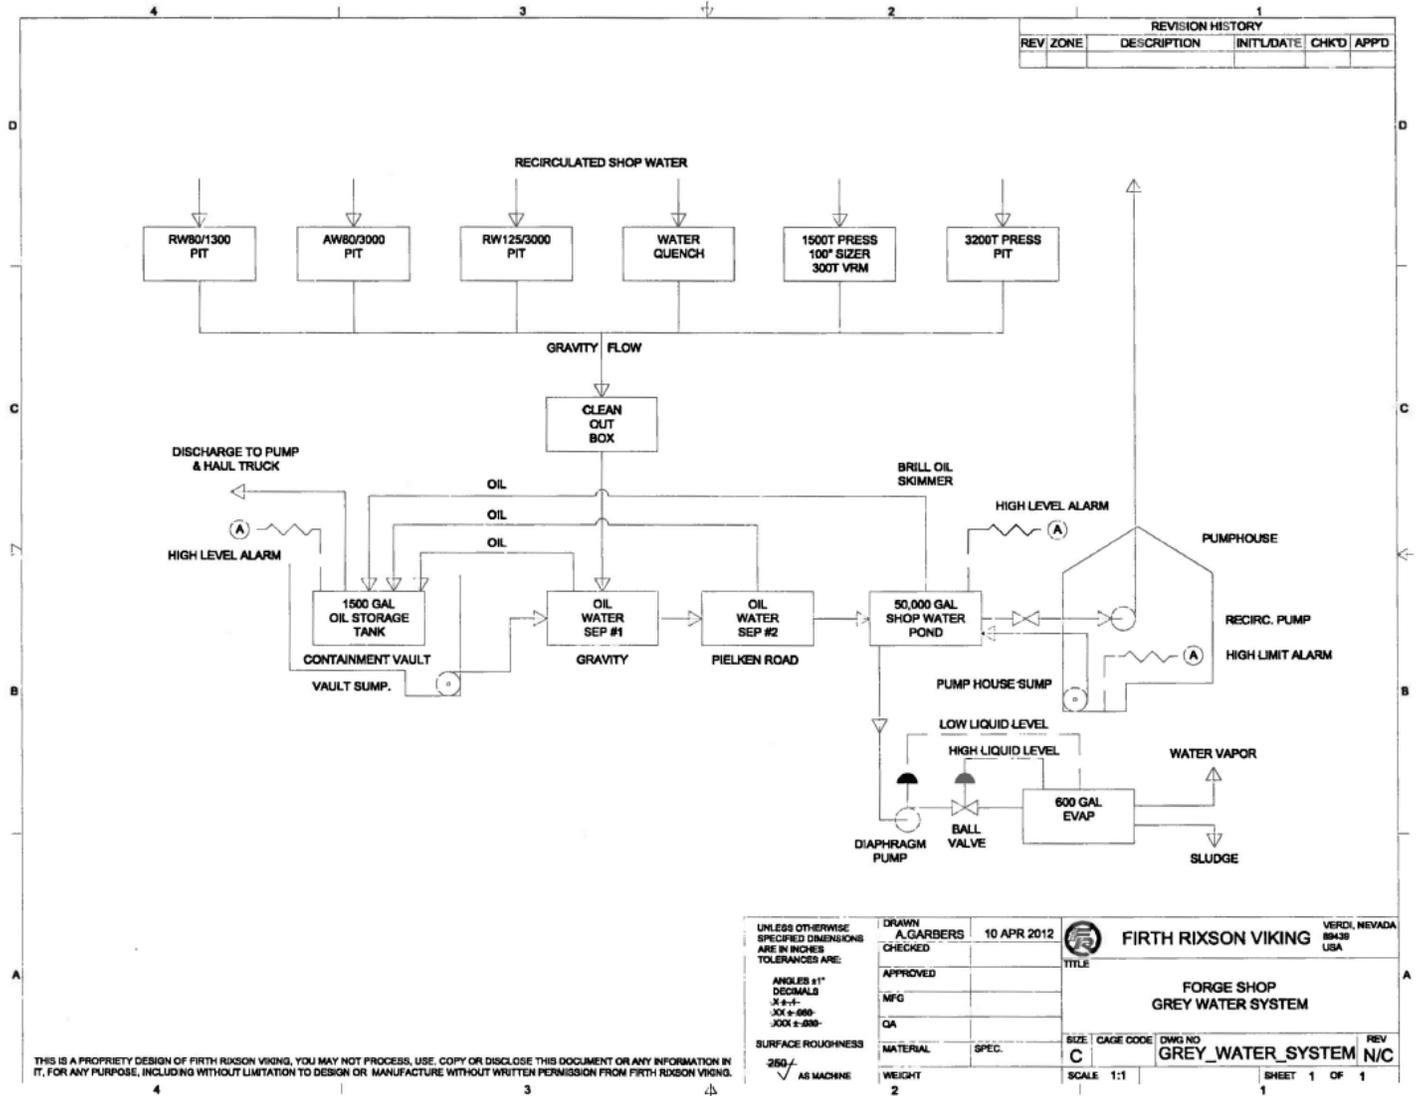
Figure 3 - Grey Water Schematic

water. The water used for cooling is water from Arconic's zero discharge grey water system. Water from the Shop Pond is delivered on demand to the manufacturing equipment for cooling. This cooling water may come in contact with hydraulic fluid and equipment lubricants. The cooling water can also be applied manually with hoses near the machine. Reuse cooling water is also used in a smaller quench tank located in the machining building that is used to "freeze" half of the item. Spent cooling water is collected in a series of sumps located below the machinery and is then piped to a cleanout box for large debris removal. From the cleanout box, water flows by gravity to two in-series oil/water separators. Separated oil is collected in a 1,500-gallon above-ground high density polypropylene (HDP) used-oil storage tank for removal by a licensed waste-oil disposal company. Water from the oil/water separators is then piped to a 50,000-gallon concrete pond (Shop Pond) where any remaining surface oil is removed by an oil skimmer. Removed oils are discharged to the 1,500-gallon used-oil storage tank. The used-oil tank and the Shop Pond are equipped with high liquid level alarms. 600 gallon evaporator is also utilized to evaporate water from the Shop Pond. A schematic of this zero-discharge grey water system is located in Figure 3.

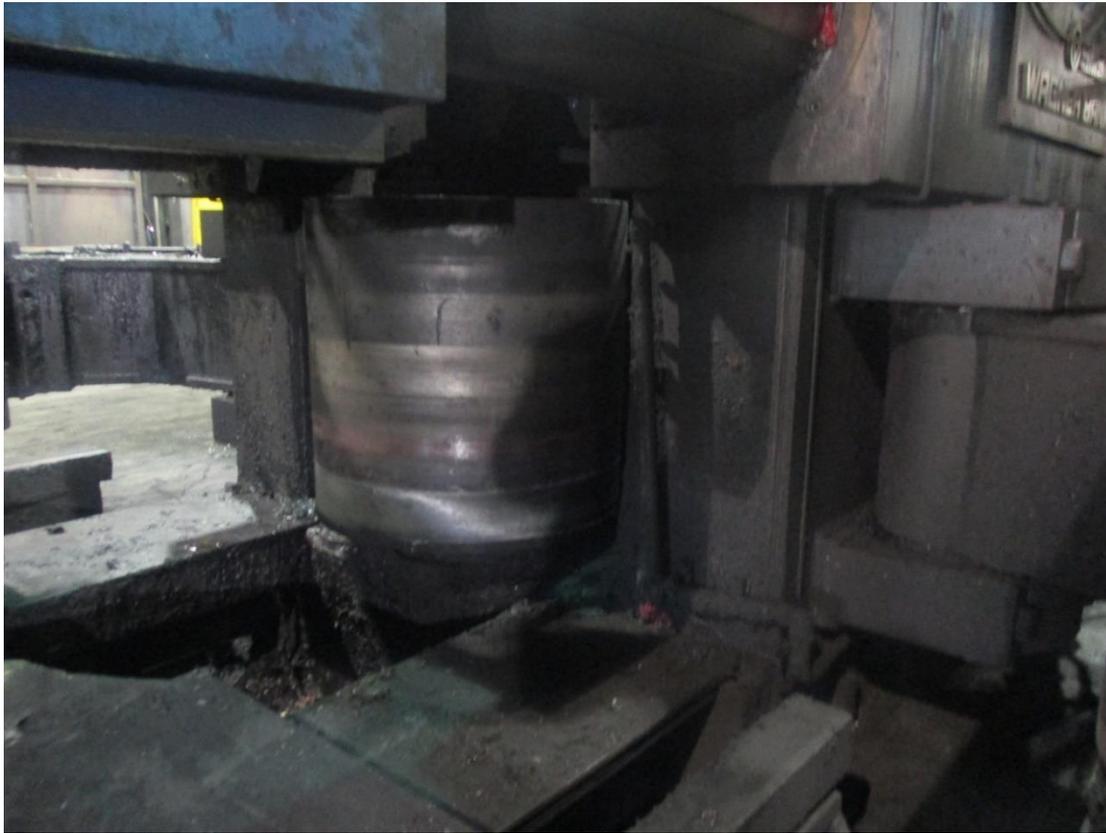
Figure 4 - Machine with automatic cooling water distributor, sump located under machine

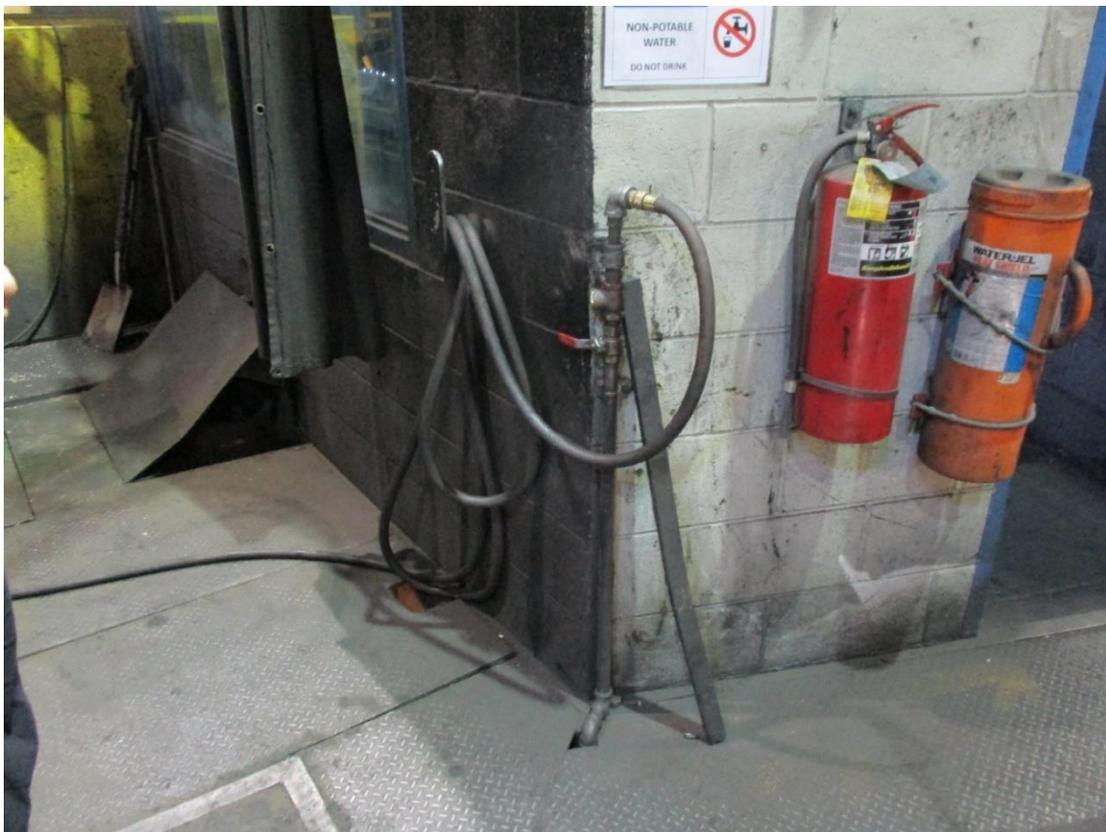
Figure 5 - Manual spray to distribute cooling water

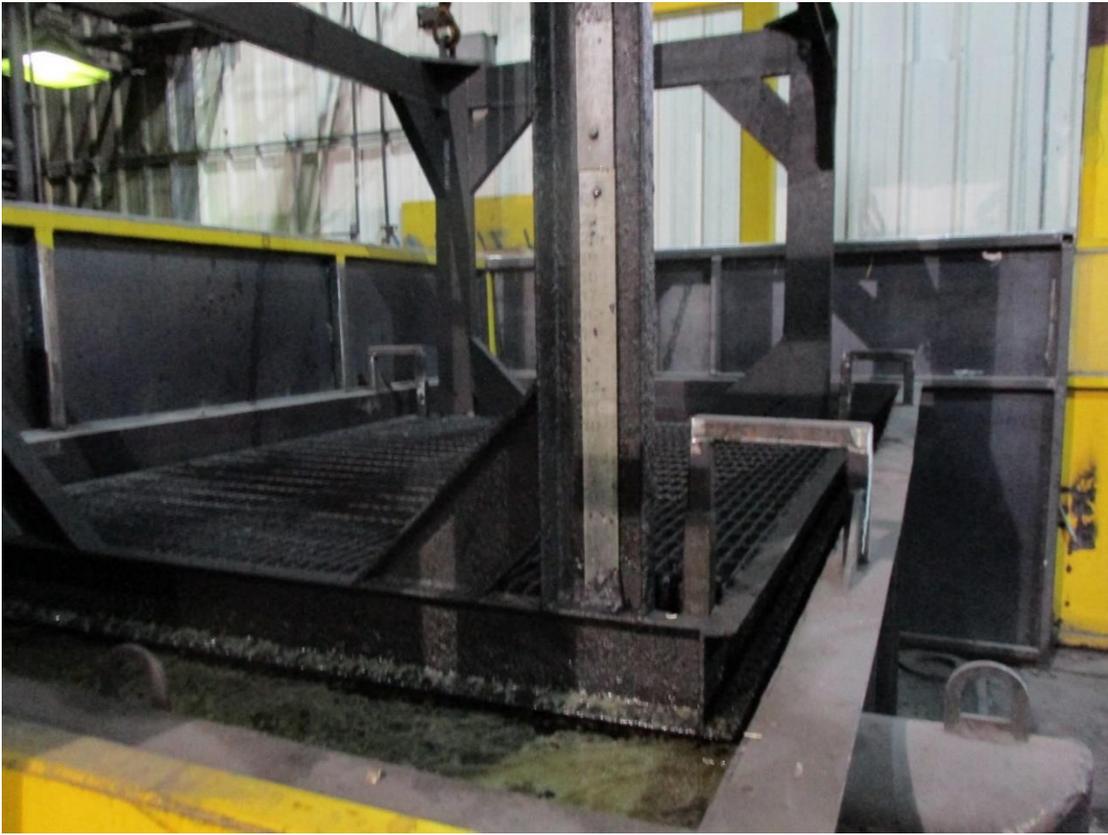
Figure 6 - Small quench tank that utilizes recycled cooling water

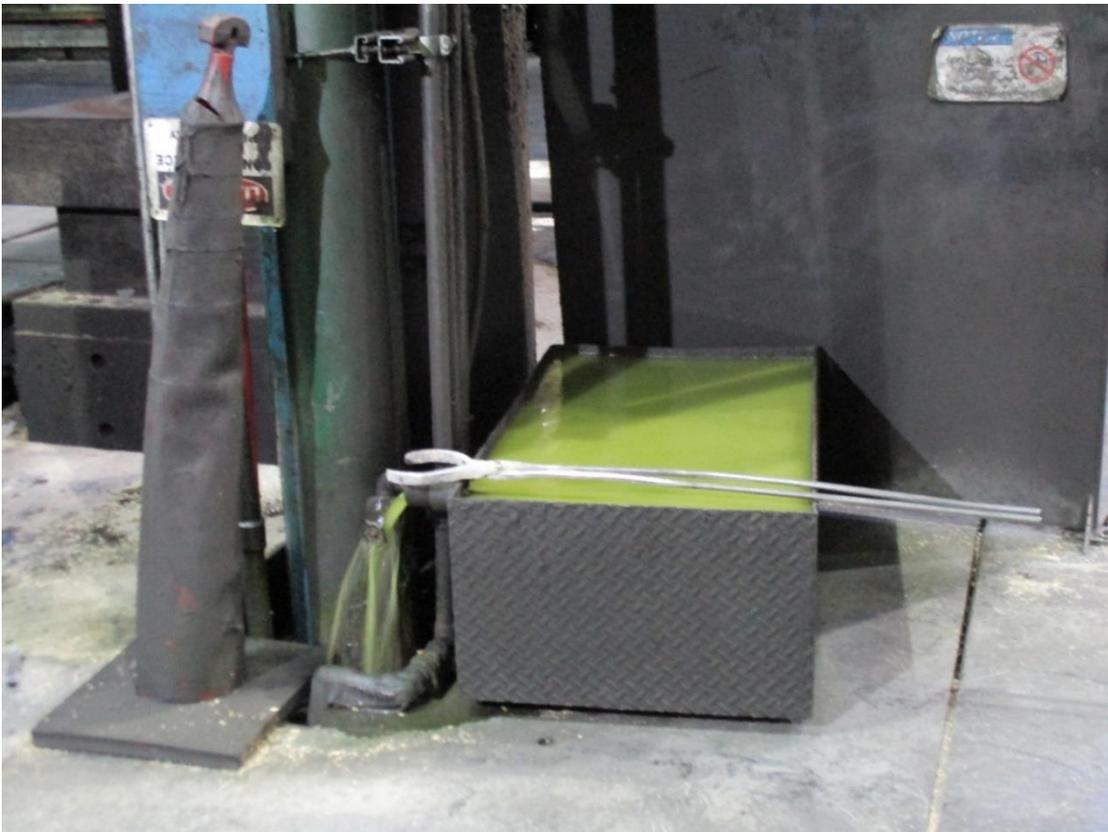
Figure 7 - Small dip tank that uses recycled cooling water

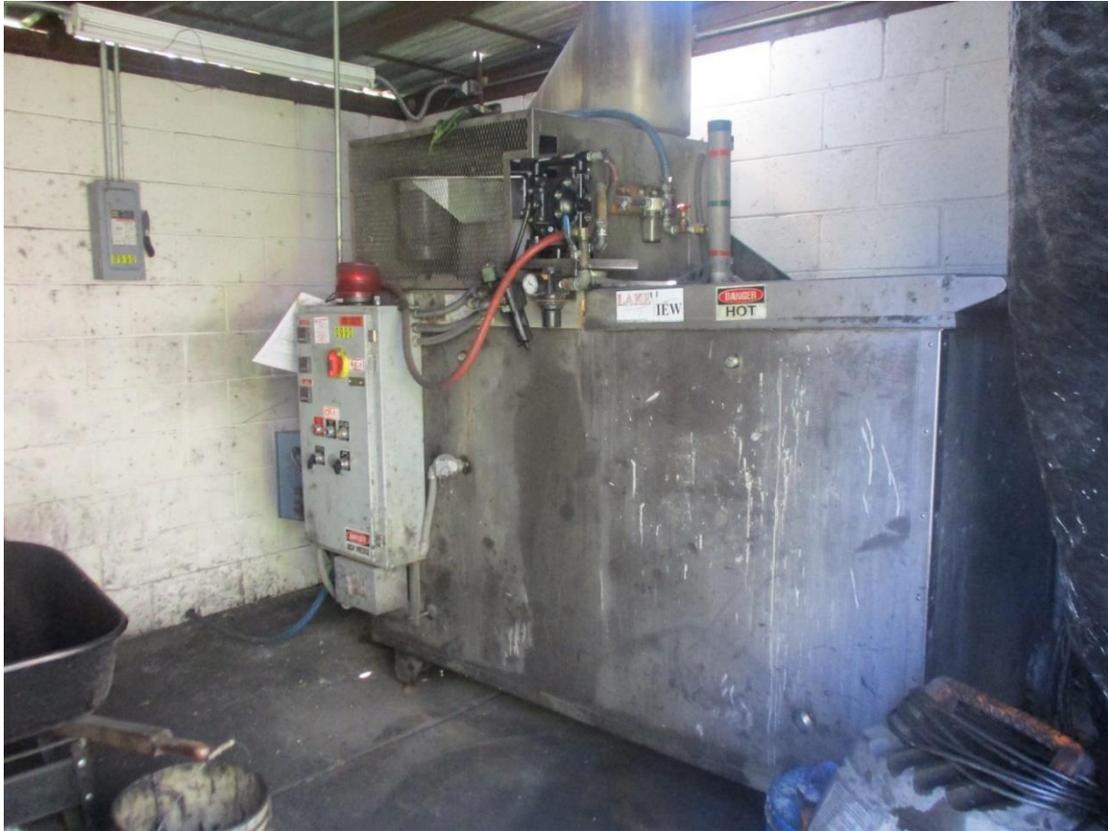
Figure 10 - 600 gallon Evaporator

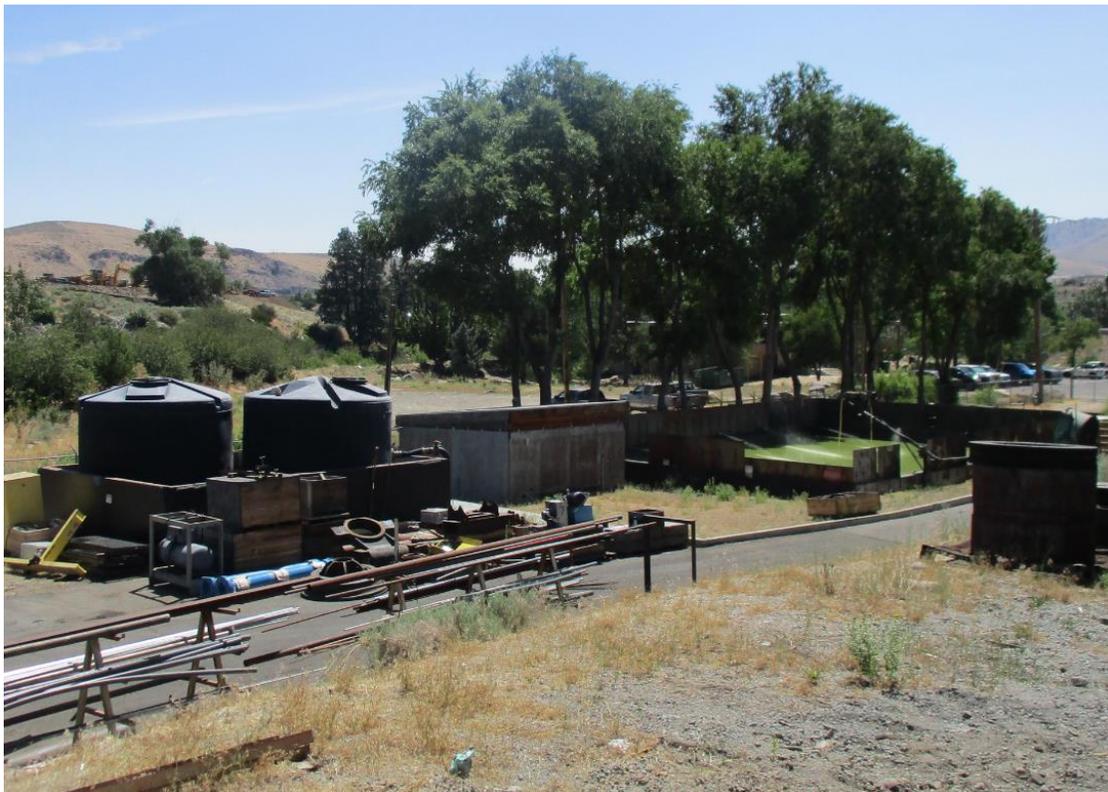
Figure 11 - Shop Pond and storage tanks

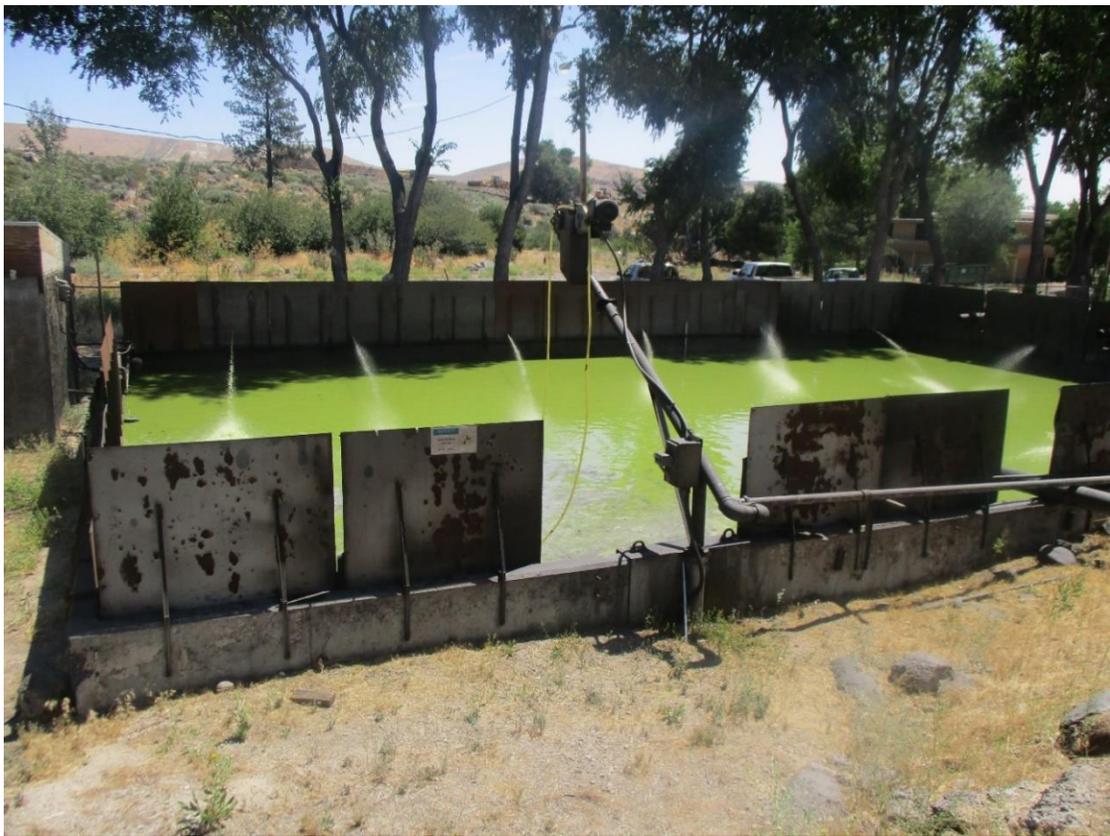
Figure 12 - Shop Pond

Eventually, the water will make it into the Shop Pond (Figure 12) where it can then be recycled for cooling water. NDEP didn't measure the freeboard in the Shop Pond, but it appeared to be approximately 2 feet. Figure 13 shows the original design plans of the concrete pond. The concrete pond was not constructed with leak detection, but was constructed with a bituthane membrane for additional waterproofing of the concrete structure. The pond was constructed in approximately 1978. It is unknown if an evaluation of the pond has ever been conducted but it is known that a full pond evaluation has not been completed in recent years.

NDEP found that Arconic is meeting the terms of its current Discharge Permit. It was noted that that Shop Pond is approximately 40 years old and should be fully evaluated to assess the integrity of the structure.

<b>No.</b>	<b>Recommendation</b>
1	Complete a full evaluation of the concrete shop pond

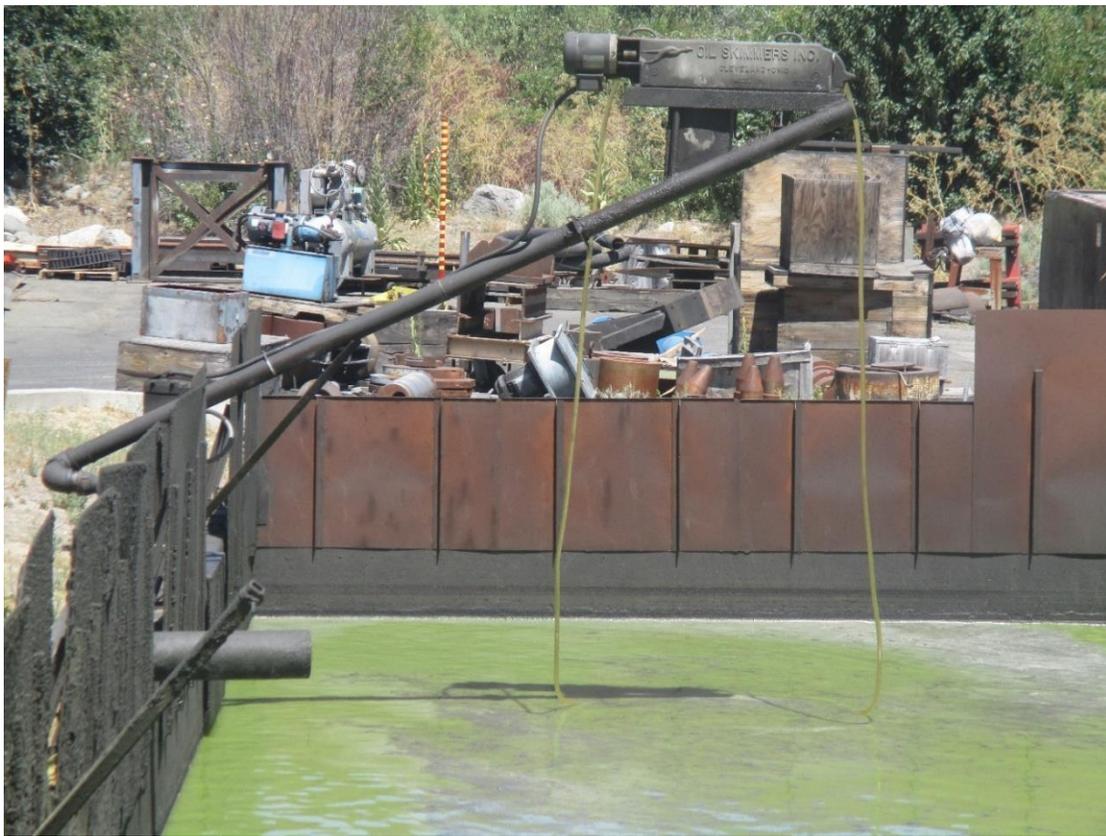
Figure 14 - Oil skimmer in Shop Pond

Figure 14 shows the Shop Pond and oil skimming unit. Numerous spray jets direct the oil floating on the surface toward the northwest corner of the Shop Pond where it can be skimmed off. The oil skimming unit is a very simple design that operates using a rotating plastic hose that picks up oil and deposits it into an opening at the top of the unit and it flows by gravity to the waste oil tank.

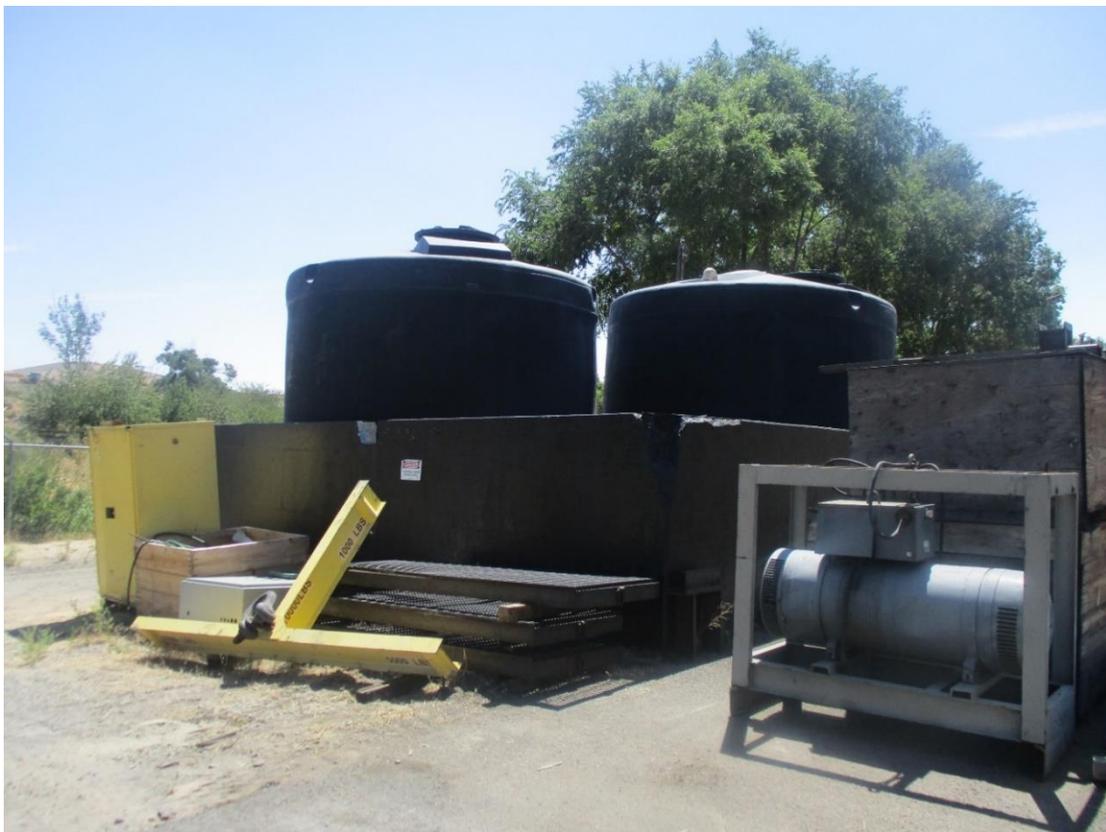
Figure 15 - Two 10,000-gallon storage tanks within concrete secondary containment

There are also two 10,000 gallon plastic tanks within concrete secondary containment, as shown in Figure 15. The two HDP storage tanks were previously used to store hydraulic fluid associated with a removed piece of equipment (cogging press). These tanks have been taken off-line and are only used for emergency storage from the Shop Pond.

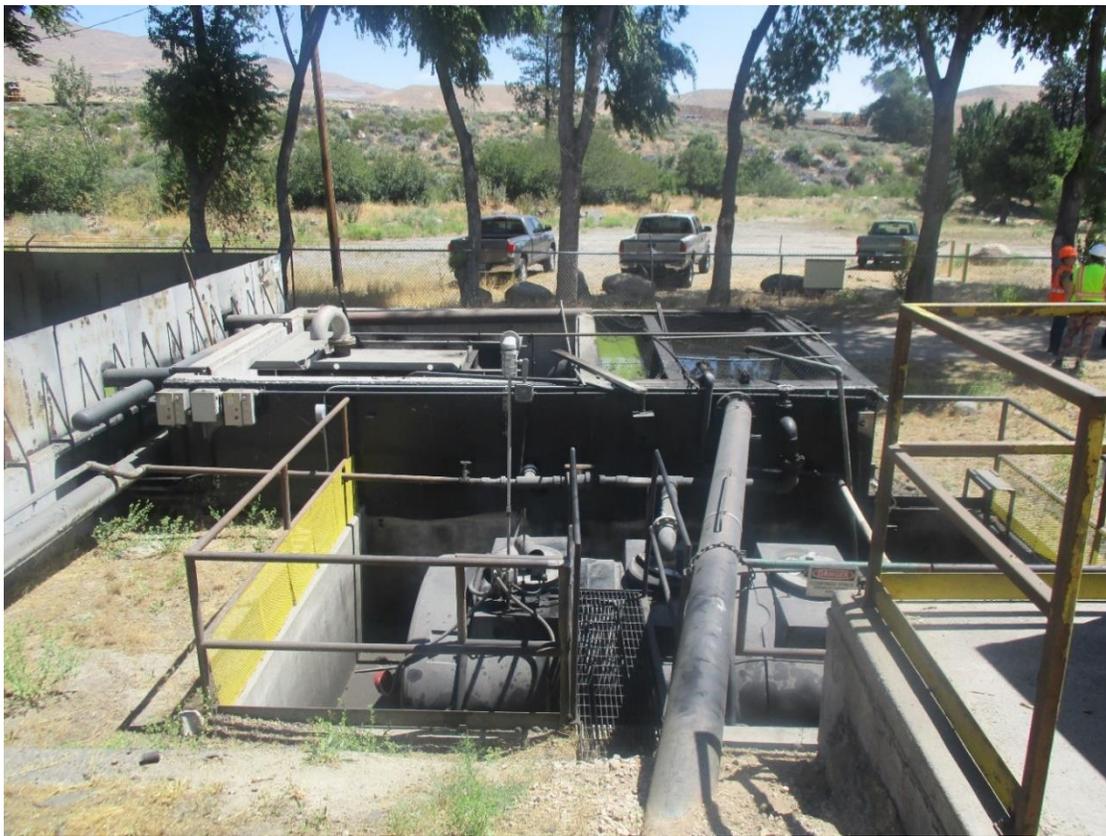
Figure 16 - Oil Water Separators in the background, Waste Oil Tank in the foreground

The two concrete oil/water separator units were full of oily wastewater. Oil is skimmed off the top of the liquid and deposited in the waste oil tank. Figure 16 shows the waste oil tank and the oil/water separators. Since the mixture contains both water and oil, excess water drops to the lower part of the tank where it can be pumped back into oil/water separator.

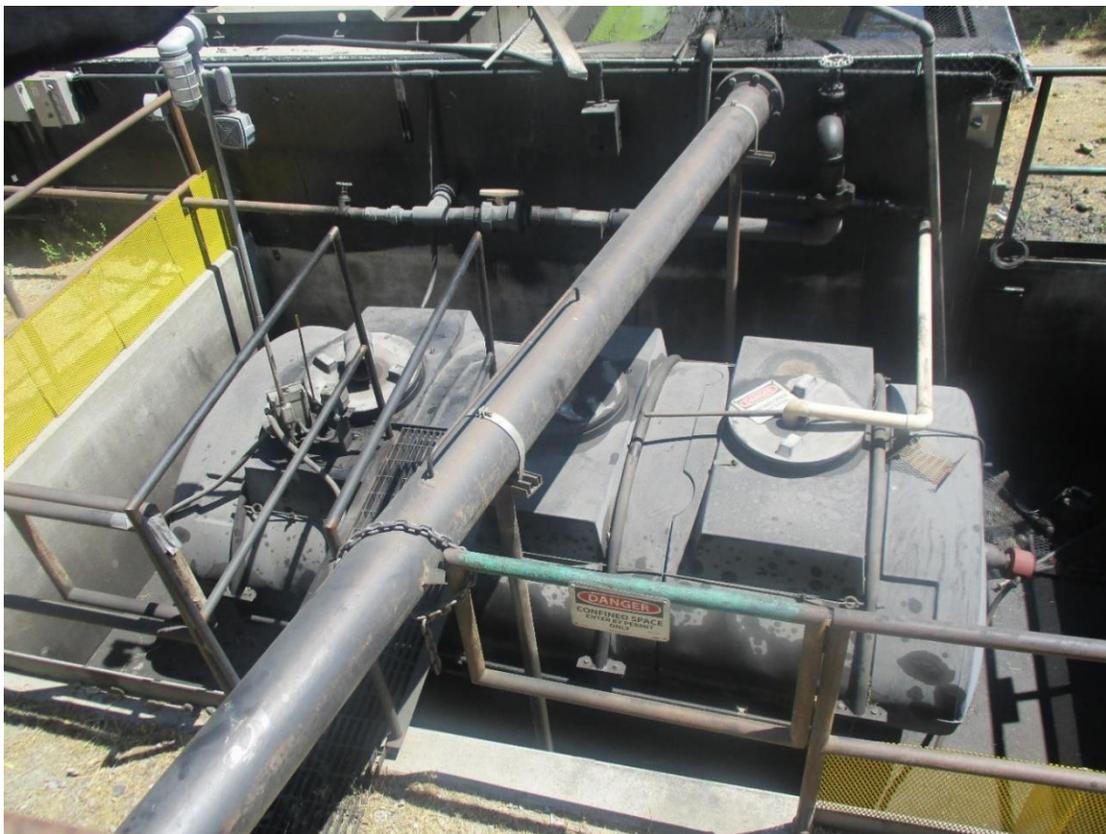
Figure 17 - Waste Oil Tank

The 1,500 gallon waste oil tank vessel was in good condition. No leakage was noted from the insulated piping and the floor of the concrete secondary containment sump was clear. The tank is emptied every three months.

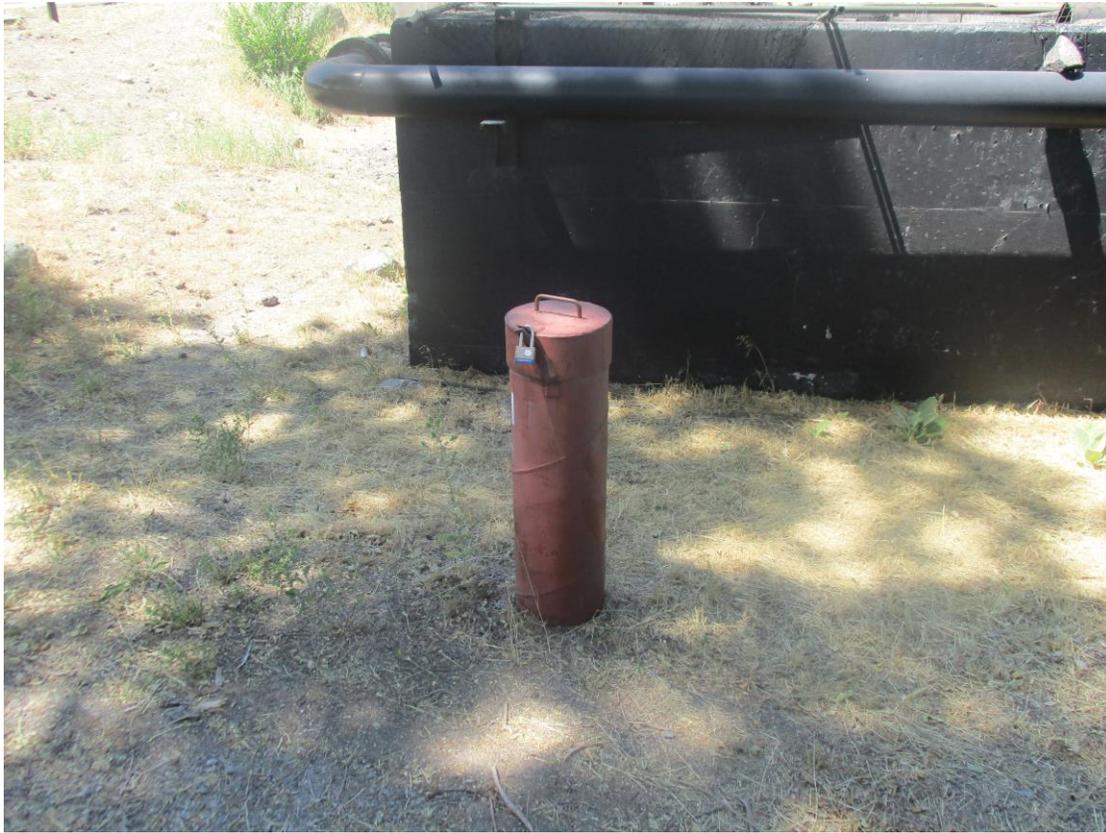
Figure 18 - Monitoring Well 1 East of the Oil Water Separators

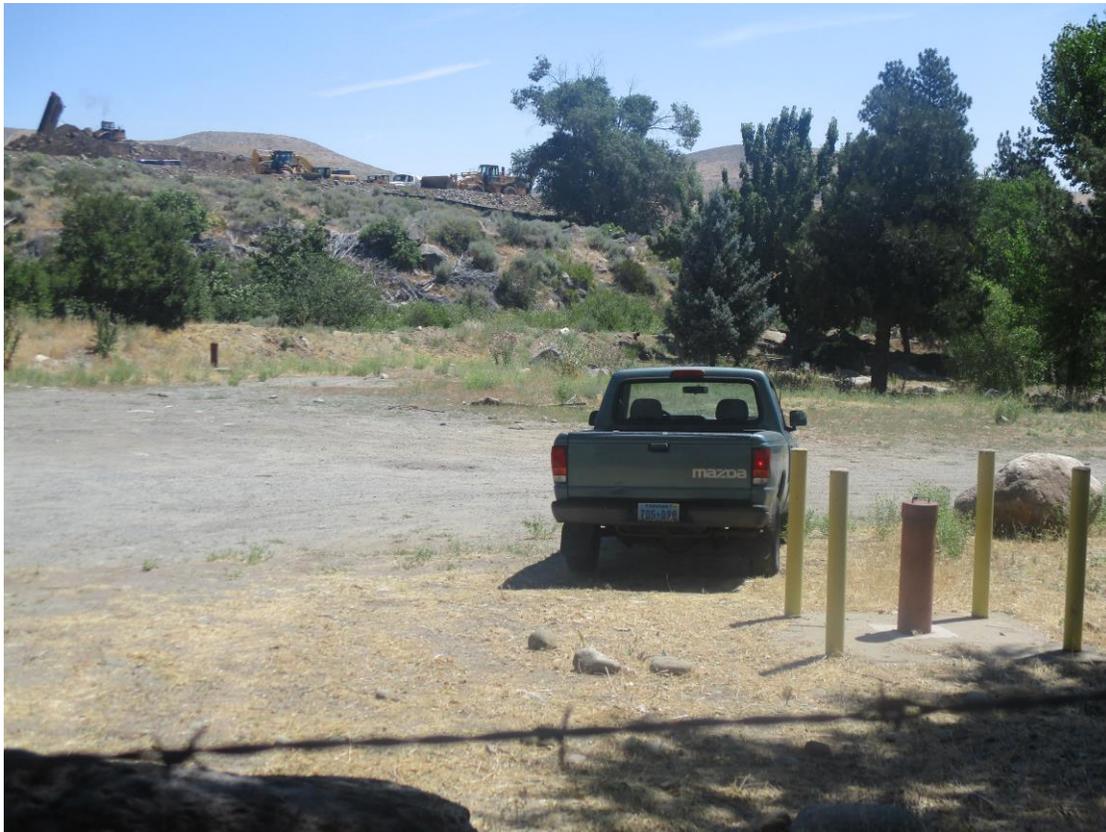
Figure 19 - Monitoring wells further East of the Oil Water Separators, with Monitoring Well 3 in the background adjacent to the river
