## 800 MHz Operating Status

#### Infrastructure Maintenance Update

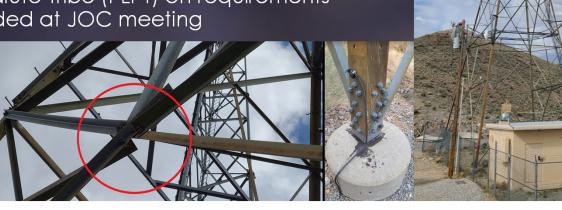
## Marble Bluff Tower Replacement

- Replace existing Marble Bluff Tower
  - 230% overloaded, and Washoe County needs to add items to tower to better support Public Safety Initiatives
  - Towers this overloaded pose a safety risk to general public and anything within the surrounding area. Big Risk include:
    - Tower Collapse
    - Wind to carry the tower off the mountain
  - Out of Compliance with ANSI/TIA-222-H Safety Requirements
  - Tribe needs tower space for Internet Circuits
- Replace existing shelter
  - Shelter contains asbestos within brick walls and roof- Asbestos remediation expensive.
  - Need HVAC needed- which requires cutting into brick
  - Need Roof repairs
  - Need Generator Replacement
  - Cost of new shelter with these fixtures included is cheaper than the maintenance of replace of all the components combined.

- Marble Bluff Tower Replacement
  - Angel Tension Steel Tower built between 1947-1967 by LADWP
  - Towers typically replaced every 50 year per OSHA/FCC "Good Engineering Practice Guide". (ANSI/TIA-222-H)
  - Structural Analysis was conducted April 20<sup>th</sup>, 2021. resulting in Marble Bluff Tower is being overloaded
    - The Tower is 230% overloaded (ANSI/TIA-222-H)
    - Second Structural Engineer came back with 200% overloaded (ANSI/TIA-222-G)
  - Replacement Efforts
    - Working on Request For Proposal (RFP)
    - Working with Pyramid Lake Paiute Tribe (PLPT) on requirements
    - More information to be provided at JOC meeting

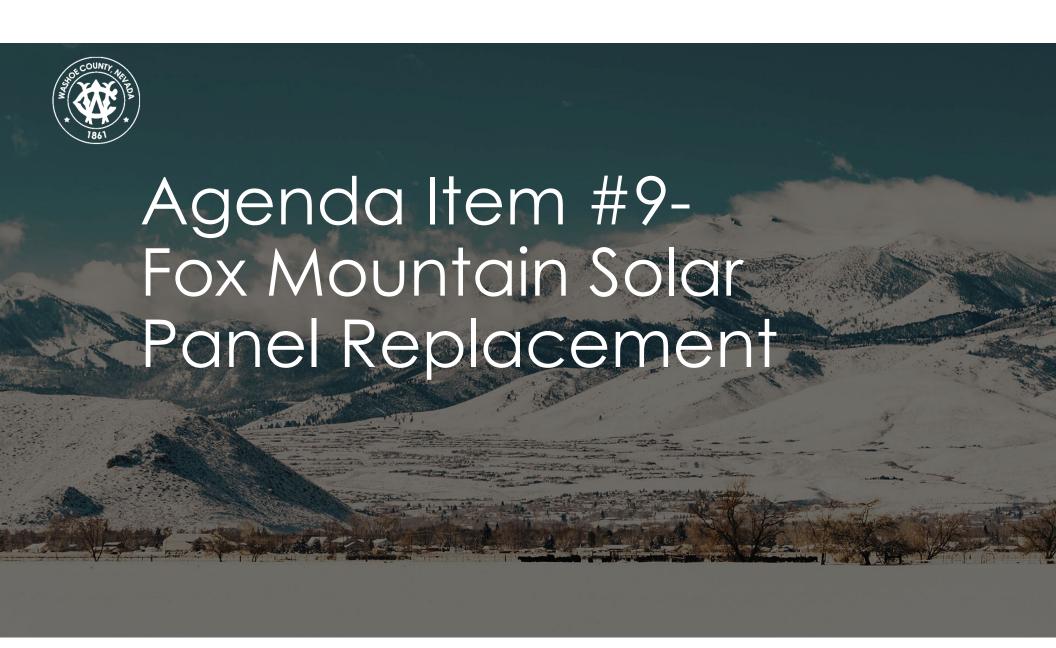
## Fox Mountain Solar Panel Replacement

- Fox Mountain Solar Panel Replacement
  - Solar Array installed between 2006-2008. (15 years old)
    - First generation Solar panels had a life expectancy of 15-20 years.
    - These panels were first generation solar panels, and are effectively operating below 30% of expected power output.
  - The Solar Array at Fox operates at a 30% decrease in power output, and will not be able to sustain current system load soon. Meaning it will not be able to carry the future P25 expected loads.
- Solar technology has changed since this install
  - Average Solar Panel now last 25-30 years
  - Older generation Solar arrays yielded 125Amp per panel, instead of newer panels that can yield 400Amps per panel
  - On Average (depending on manufacturer), the first 10 years solar panels decrease in efficiency by 10% and by 20% by reaching 25 years.

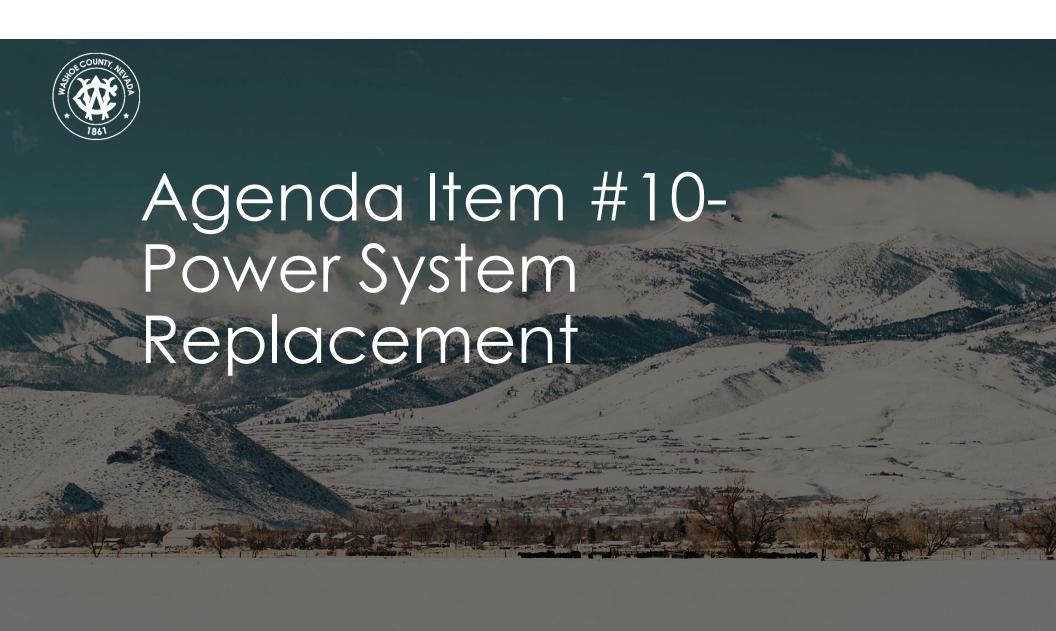
## Power System Replacement

- Grounding system remediation needed to accommodate new system
  - Snowflake Lodge
  - Marble Bluff to be included in RFP
  - Fox to be included in Solar
- Grounding practices have changed, and require upgrading to accommodate the design of new system.
- DC Power plants need to be replaced and upgraded from 24VDC system with converters to new 48VDC system.
  - Marble Bluff
  - Mt Rose
  - Slide Mountain
  - Snowflake Lodge
- Cost ~ \$40K per site
